Number	L.1
Section	Brakes
Sheet	1 (of 2)
Date	January, 1960

DISC BRAKE MASTER CYLINDER RECONDITIONING

Models affected

All cars fitted with disc brakes

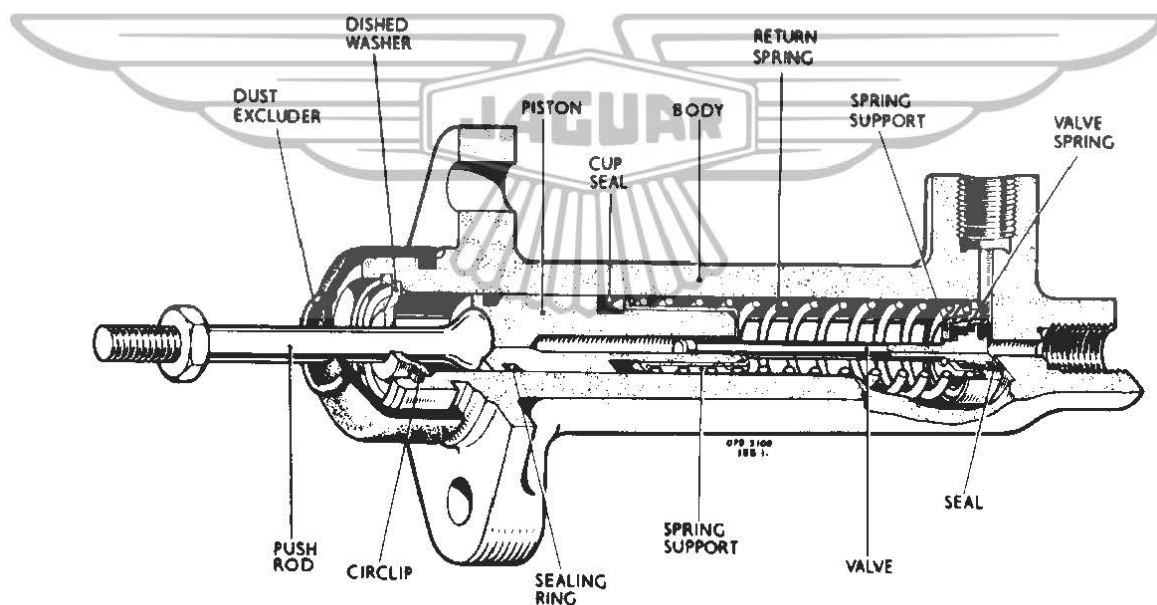
FIG. 2.

With this change the self adjustment arrangement is modified. The spring washer, shown in Fig.2, Section L of the Mark 2 Service Manual is no longer used, the retraction being by a coil spring located in the piston.
